CASE STUDY:

Fan Motor Test Reveals Damaged VFD, Prevents Safety Hazard and Process Downtime

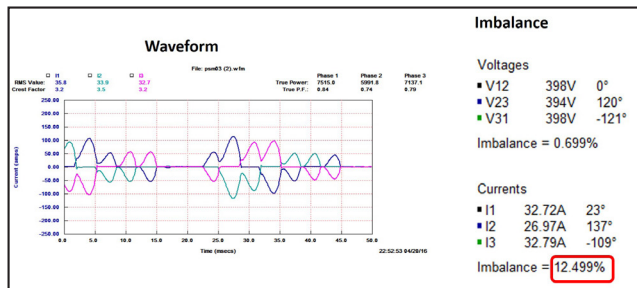
Figure 1. Measurements taken at the VFD input show an abnormal waveform. This waveform shows how the current coming into the VFD is unbalanced. For example, the straight lines from the 15 second mark to the 23 second mark are flat – which means the VFD is not receiving any current. This waveform is not normal for a healthy VFD (a normal waveform at VFD input should look like the waveform in Figure 3).

The fan is comprised of an impeller keyed directly to the motor shaft, which is controlled by a variable frequency drive (VFD). Di Pasquale used the ALL-TEST PRO On-Line II™ energized motor testing instrument to test the fan motor and discovered significant current imbalance at the VFD input and output (see Figure 1 and 2).

"Testing showed a current imbalance of 12.4% at the input of the VFD that became 74.8% at the output of the VFD," explains Di Pasquale. "This is not good for the motor – the VFD should supply the fan motor with balanced current. Given such high levels of current imbalance and the absence of several input half-waves, it became clear to me that the motor and fan were fine, but that the VFD needed to be replaced."

Di Pasquale discussed the issue with the owner of the facility. He explained that this current imbalance was likely a result of an internal problem with the VFD and recommended the VFD be replaced. Even though the fan could operate with this VFD-driven motor, the motor would eventually become damaged as a result of the current imbalance.

Trusting Di Pasquale's recommendation, the paint producer had the VFD removed and confirmed that there had been serious damage to the VFD's internal diodes. The paint producer ordered a new VFD and was able to maintain production while waiting for the new inverter, which took 10 days to arrive. After the new VFD was installed, Di Pasquale went back to the facility to test the fan motor with the new VFD. The second round of energized motor testing with the ATPOL II™ showed healthy waveforms (Figure 3 & 4).

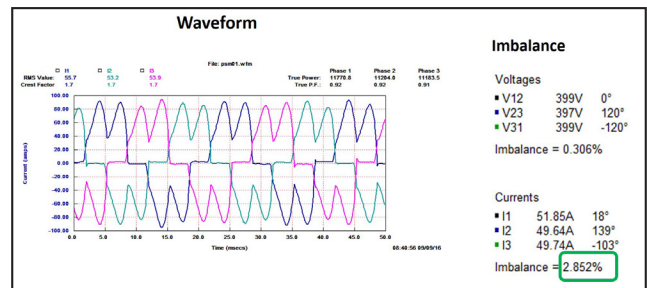
Figure 3. VFD input measurement following replacement.

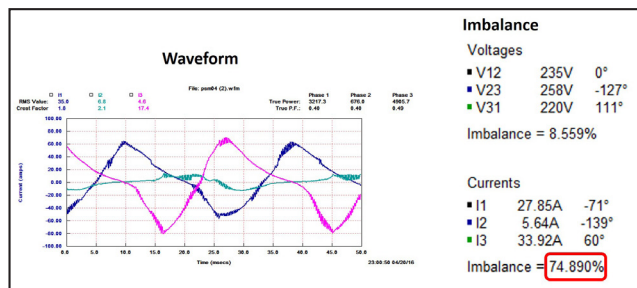
Figure 2. Measurements taken at the VFD output show significant imbalance that exists in the current fed to the motor. As you can see, the green waveform (phase 2) should be similar in shape to the blue (phase 1) and pink (phase 3) waveforms, but it is drastically different. This waveform is not normal for a healthy VFD (a normal waveform at VFD output should look like the waveform in Figure 4).

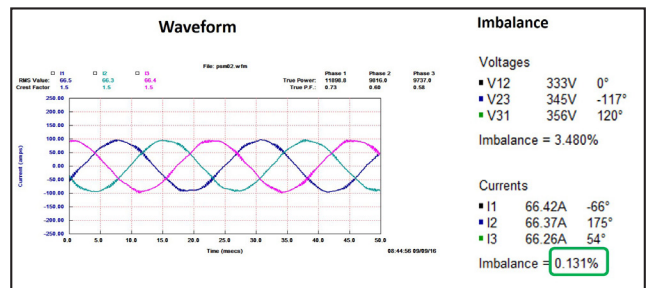
Figure 4. Output measurement of new VFD (all three current waveforms are normal).
