Customer Case Study

Detection Of Arcing Faults In Generator Winding Prevented \$0.5 Million In Potential Losses

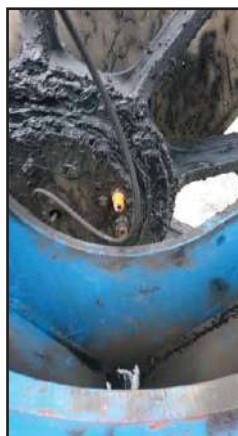
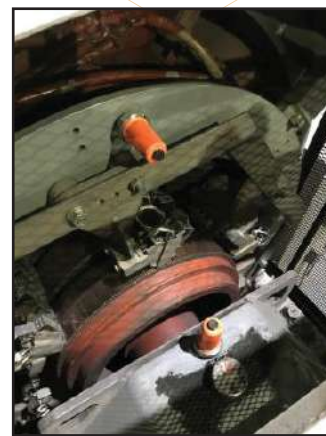
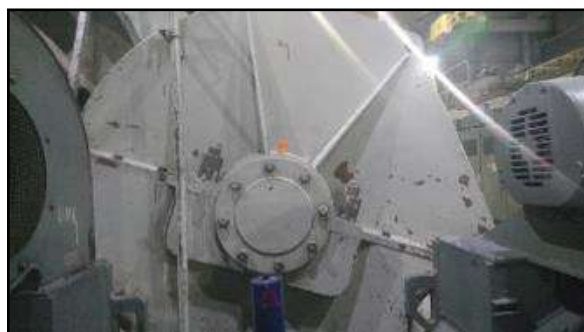
We proposed our RotationLF system under which we installed around 30 wireless sensors as a part of a pilot project: 17 on the M8750 & the rest on M8200 as shown in below images.

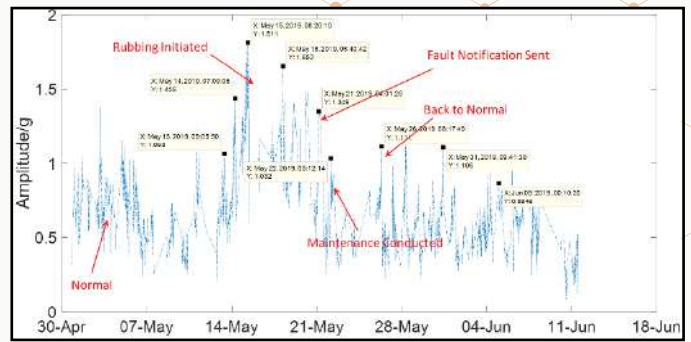
All these sensors were installed on April 30th. After 15 days only, the RMS trend plot generated from vibration data sent by sensors showed an upward trend indicating anomaly behavior as shown on the plot on the right. On May 21st, a fault notification was sent and corrective action was taken on May 22nd. By May 31st, the readings went back to normal.

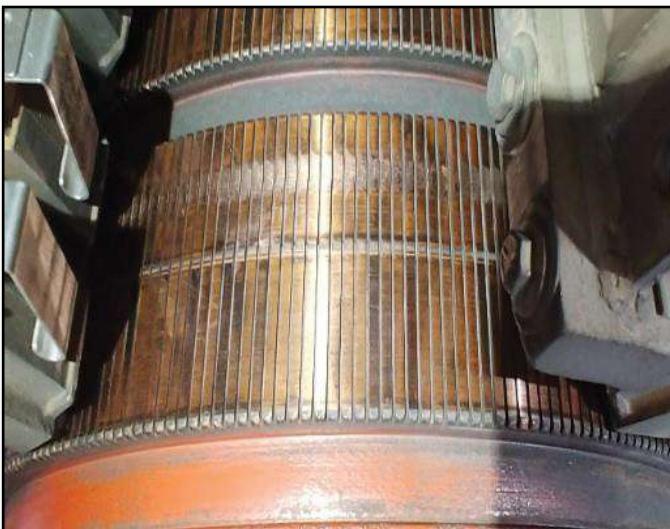
Rub marks generated due to carbon rod rubbing against the copper lining

The RotationLF analytics sensed & detected the anomaly in the pattern and alerted Westmoreland staff about this unusual trend automatically through mobile text and email alerts. When the Westmoreland engineers opened the generator during one of the available down times, they found that the spring suspended underneath one of the carbon rods had snapped and as a result, the carbon rod started rubbing against the commutator (image on left). The plant engineers then undertook immediate repair action.
